What is "Stray Voltage"?

Today we are going to spend some time talking about a recent UTEC investigation in which equipment operators working in a rock quarry received shocks when touching grounded equipment.

Photographs

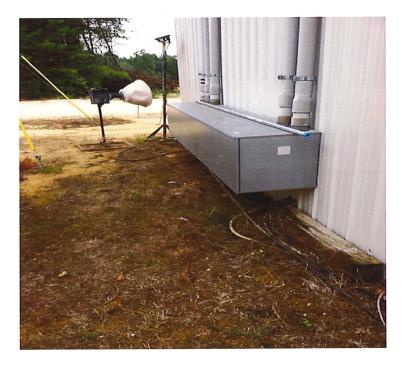
T1 Service Conductors

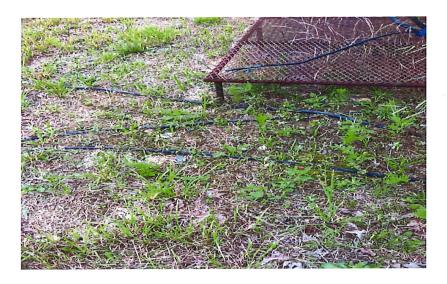
T1 Service Wire Way and Grounding Trough

- 750 kVA, 12.47 / 7.2 kV grounded wye to 277/480 ungrounded wye transformer
- Messenger cable of 600 volt quadriplex conductors metallically connected to power utility primary neutral and on customer end connected to a pre-fab metal building using steel eye bolts

- Customer has two ground rods installed outside its metal building with bare copper ground conductor brought into metal enclosure where attached to the metal building

- The metal building provided a metallic connection between the power utility primary neutral and the customer ground
- Customer service into the quarry uses flexible 3-phase cables with no. 6 copper insulated conductors per phase, no. 6 insulated ground conductor, designed to lie on the ground, extending 1000 to 1500 feet from the service ground

UTEC requested the Power Utility modify its service conductor connections to the metal building, insulating the messenger from the building and thus separating the utility neutral from the quarry ground system. UTEC made voltage measurements between the quarry ground system conductor and a disconnect switch support structure in the quarry about 1500 feet away from the T1 service before and after the modification as follows.
